Remote diagnosis of a pure *Half X* vibration problem in a power plant

by **Bryan Finch**

Bently Nevada United Kingdom

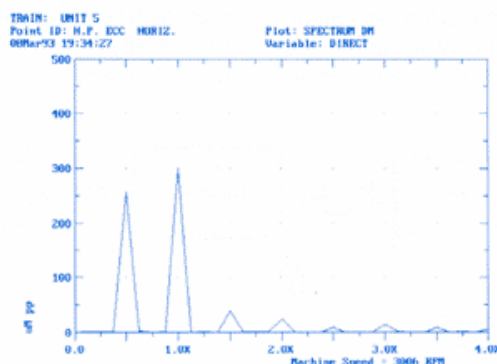
In March 1993, the machine was shut down over a weekend. No work was performed on the turbine, but on the subsequent startup, vibration levels fluctuated. The horizontal vibration level reached $430\text{ }\mu\text{m}$ (17 mils), with a 1X component of $300\text{ }\mu\text{m}$ (12 mils) and a component at exactly 0.5X running speed of $260\text{ }\mu\text{m}$ (10.2 mils). (Note: individual vibration components do not sum arithmetically to give the overall value.)

Figure 2
Spectrum plot, showing high vibration levels on the No.1 bearing.

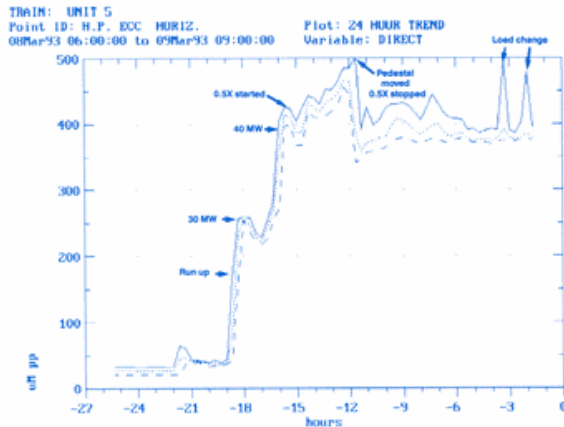
Upon startup, the same problems occurred, and additional plots were faxed to MDS. The direct (overall) 24-hour vibration trend plot (Figure 3) shows how the vibration levels varied. The three lines (solid, dotted and dashed) on the plot show maximum, average and minimum values, respectively. At a 30 MW load, there was no 0.5X vibration present, and the overall vibration level was $270\text{ }\mu\text{m}$ (10.6 mils). The 1X vibration component increased with increasing load, and at 40 MW, the 0.5X component appeared, at a level of $260\text{ }\mu\text{m}$ (10.2 mils). The 1X vibration component had increased to $400\text{ }\mu\text{m}$ ▶

(15.7 mils). The two components combined to give overall levels of 450 to 500 μm (18 to 19.7 mils).

As the 1X vibration component level was not excessive when the machine reached running speed but increased with increasing load, unbalance was ruled out as the cause of the high 1X values. Alignment problems were suspected.

Figure 3
24-hour trend plot of the No.1 bearing overall vibration as load was applied.

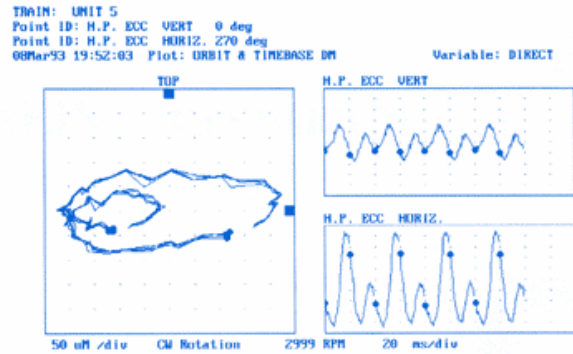
The 0.5X component remained until further temperature changes occurred. The pedestal moved again, and the 0.5X component disappeared. The vibration decreased to approximately 400 μm (15.7 mils). The turbine ran at this vibration level until it was shut down due to a boiler tube leak. Figure 4 shows the unfiltered orbit and waveforms when the 0.5X component was present.

The No. 1 bearing clearance had been acceptable and no other source of looseness had been established. The 0.5X component was related to temperature and HP pedestal movement. The most likely cause of the 0.5X component was a

rotor-to-casing radial rub, as the HP casing became distorted when the HP pedestal stuck on its slides. The orbit's shape indicated that the rub was occurring at the left-hand side of the casing, at the nine o'clock position, as viewed from the driver end of the machine.

Figure 4
Unfiltered orbit and timebase plot when the 0.5X vibration component was present.

The top half HP casing steam glands at the No. 1 bearing end were removed and indications of a rub were seen at the nine o'clock position, as had been predicted from the unfiltered orbit plot.

The No. 1 bearing was moved 0.25mm (10 mils) to the right to increase the clearance between the shaft and the left-hand side of the casing.

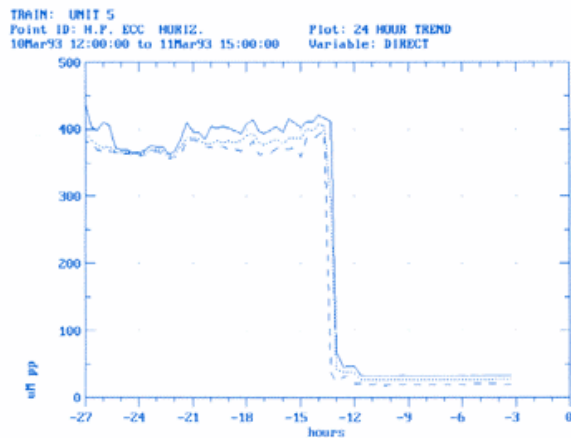
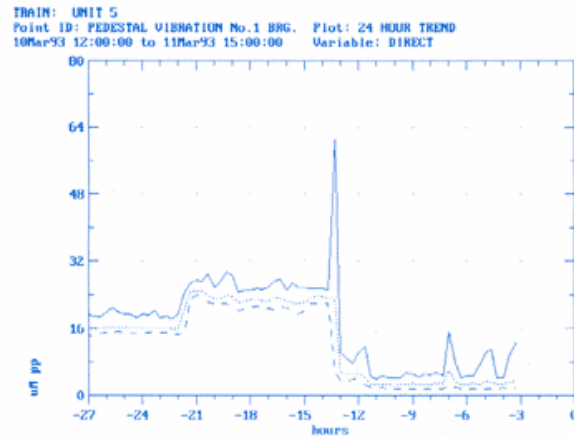
Figures 5 and 6 show the HP horizontal vibration and pedestal overall vibration trends from the time the 0.5X vibration disappeared until the machine was shut down.

At approximately 3:00 PM on March 10, the average vibration reading at the No. 1 bearing was approximately 370 μm (14.6 mils), while the pedestal vibration level was 16 μm (0.63 mils), a shaft to pedestal displacement ratio of 23 to 1. As it is well-known that this type of bearing pedestal does not have a high mechanical impedance, this ratio was considered to be high. Therefore, it was concluded that only low levels of force were transmitted through the bearing oil film to the pedestal, in spite of the large amplitude of the shaft motion.

It is also noteworthy that the force transmitted to the pedestal increased disproportionately as more of the bearing clearance was taken up by the shaft motion. At 6:00 PM, vibration at the bearing had increased to 390 μm (15.4 mils), a 5.5% increase. However, the pedestal vibration had increased to 24 μm (0.94 mils), a 44% increase. Based on the available information, MDS concluded that the No. 1 bearing was misaligned and was low, partly as a result of settling. Therefore, the bearing was not providing adequate support for the HP shaft.

Figures 5 & 6
Shaft and pedestal 24-hour trend plots from when the 0.5X vibration component disappeared to shutdown.

In a phone conversation with the plant engineer, MDS discussed their conclusions regarding both the rub and the No. 1 bearing alignment. The engineer checked the original alignment catenary figures, which confirmed that the No. 1 bearing had been low following the overhaul. During a shutdown over the following weekend, the HP pedestal was raised by 0.5 mm (20 mils). Since the HP casing is attached to the pedestal, the move didn't affect internal alignment between the shaft and the HP casing.

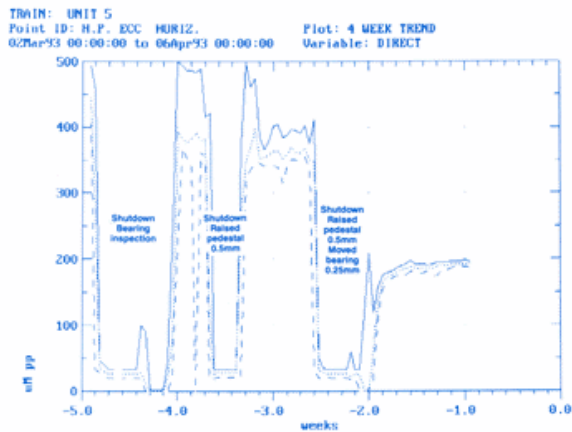
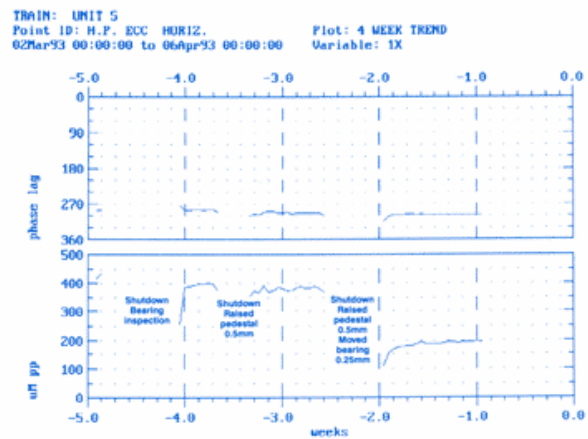
When the turbine was restarted, the rub still occurred for part of the running time, but the underlying 1X vibration level was approximately 20 μm (0.8 mils) lower as a result of the pedestal move (Figures 7 and 8).

Following the moves, the turbine ran with overall and 1X vibration levels of 200 μm (7.9 mils) (Figures 7 & 8). The HP pedestal horizontal vibration level was 25 μm (1 mil). No subsynchronous vibration occurred, and the load could be varied as required without causing significant vibration changes. The vertical alignment change reduced the high 1X vibration and the horizontal bearing movement eliminated the 0.5X component. The problems were resolved without sending a vibration specialist to the plant. The on-line data captured and plotted by the TDM System enabled MDS engineers to diagnose the problem from a remote location. ■

Figures 7 & 8
4-week overall and 1X trend plots, showing lower vibration levels after the change.

The HP pedestal was raised 0.5mm (20 mils) more to provide additional load to the bearing.
